**CWA COMPLIANCE EVALUATION INSPECTION REPORT
U.S. ENVIRONMENTAL PROTECTION AGENCY, REGION 5**

Purpose: Compliance Evaluation Inspection

Facility: Ex. 6 (Personal Privacy) Dairy Farms

Date of Inspection: November 21 – 22, 2019

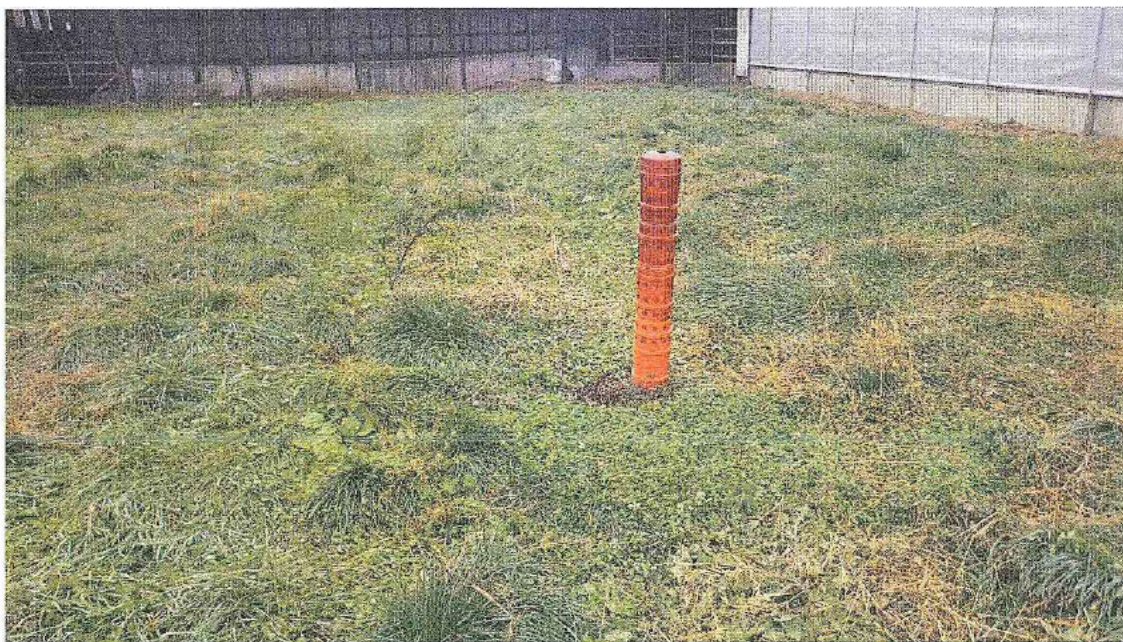
7: RIMG0007

Description: Orange surface drain riser located in grassed area between North Barn (right) and South Barn (left).

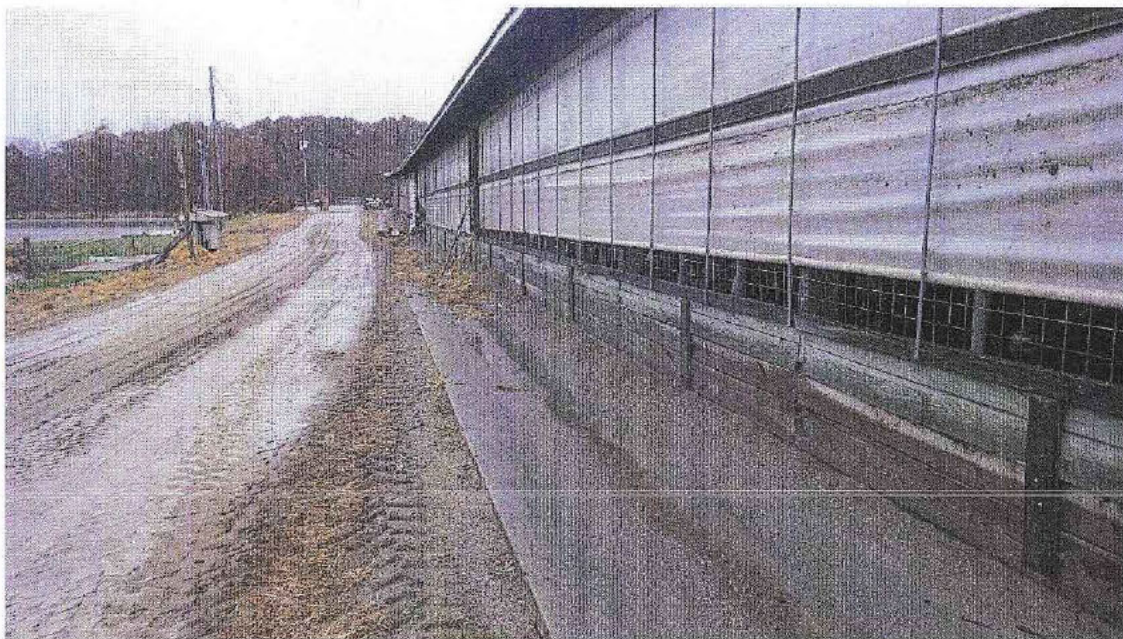
8: RIMG0008

Along the south side of the south barn, we observed runoff from the gutters co-mingling with some runoff from the barn and entering a storm inlet that Ex. 6 (Personal Privacy) said is connected to the underground County Drain running south on the east of the Facility (photos 8 and 9).

EPA observed a concrete stormwater swale that, according to Ex. 6 (Personal Privacy), flowed to a stormwater underground County Drain with water that had come into contact with bedding material from the South Barn.

Description: Looking west along south side of South Barn (right). Note concrete storm water swale leading to surface drain.

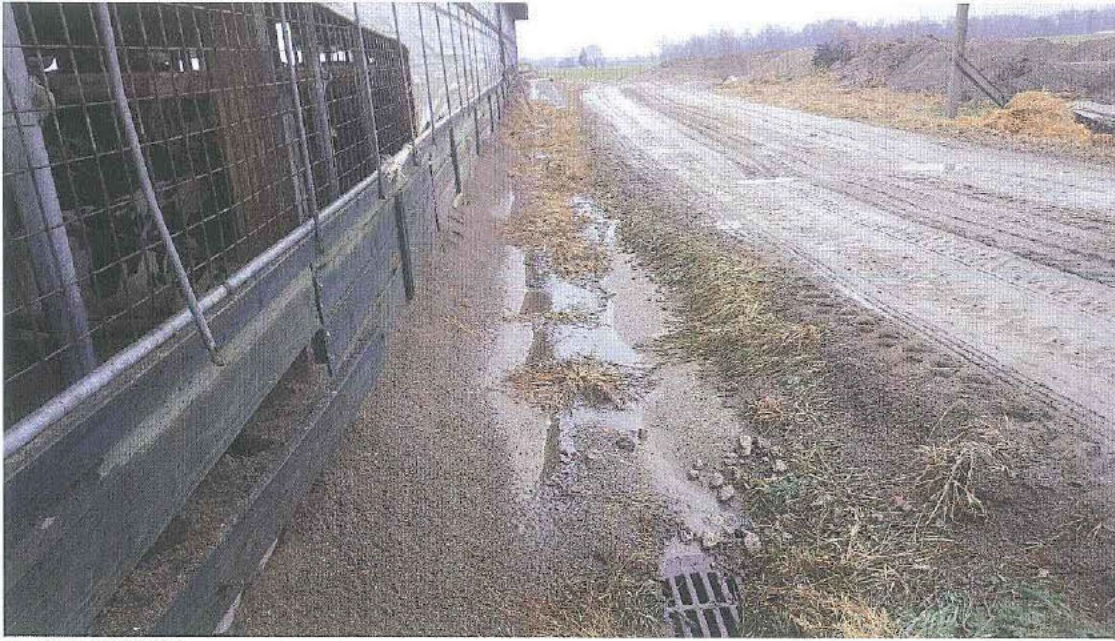
9: RIMG0009

Description: Looking east along south side of South Barn. Note surface drain in the foreground and the stormwater swale along the edge of South Barn.

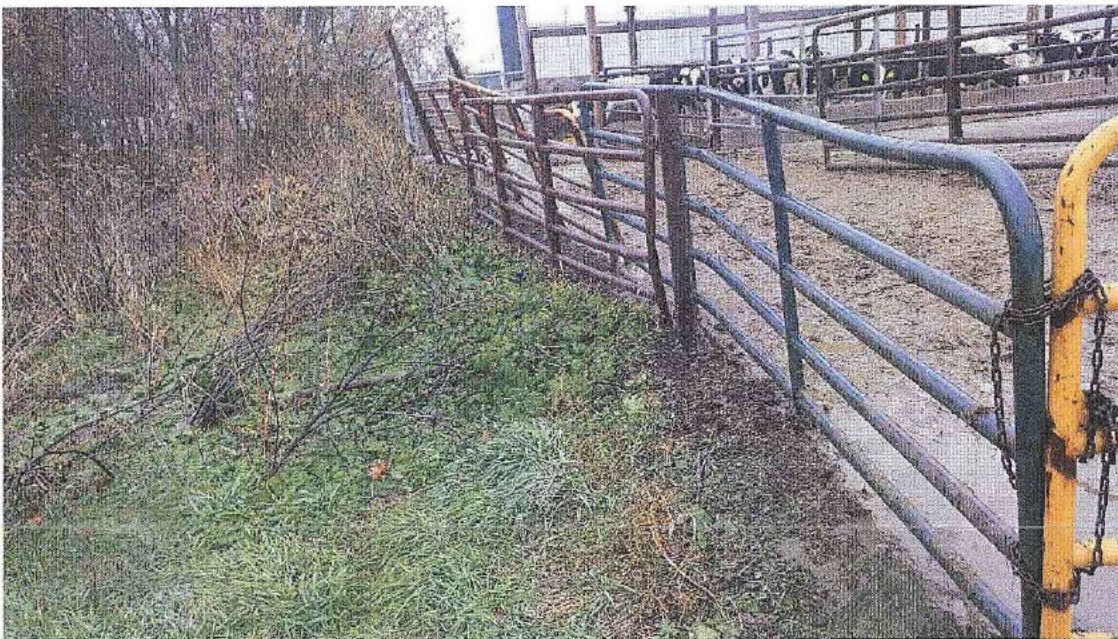
12: RIMG0012

On the west side of the Facility and north of Pit 3, we observed a weaning pen that had some standing contaminated water at the west edge of the pen. Ex. 6 (Personal Privacy) stated that the pen gets scrapped and the water drains east towards Pit 3 (photos 12 - 15).

Description: Looking north along west side of the outdoor lot associated with the Weaning Pen.

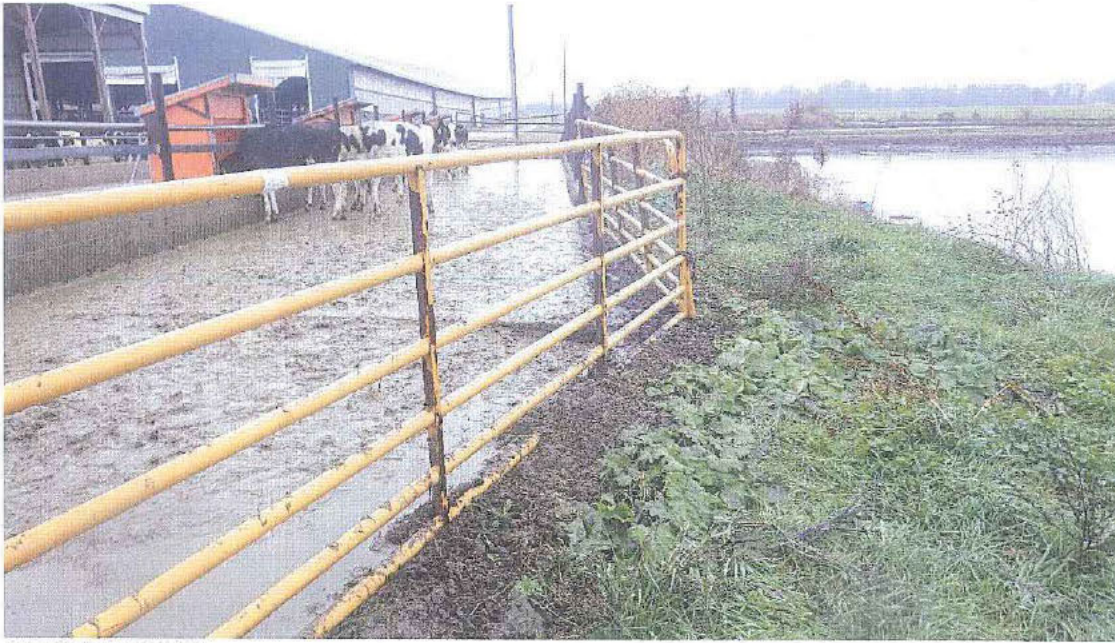
13: RIMG0013

Description: Looking east along south side of the outdoor lot associated the Weaning Pen.

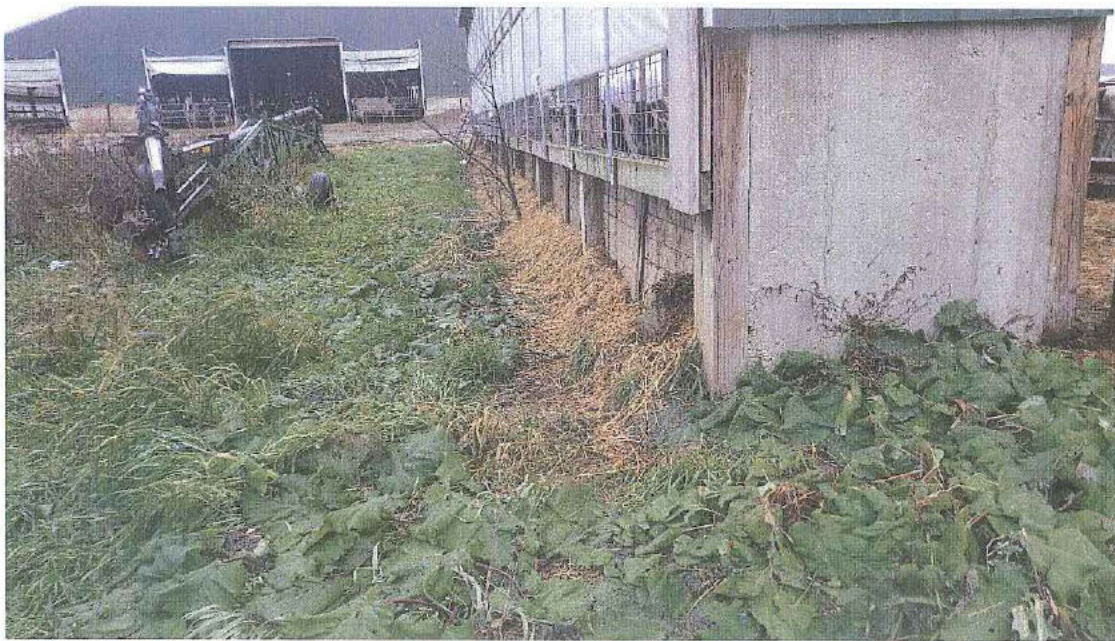
14: RIMG0014

Description: Looking east along north side of the Weaning Pen.

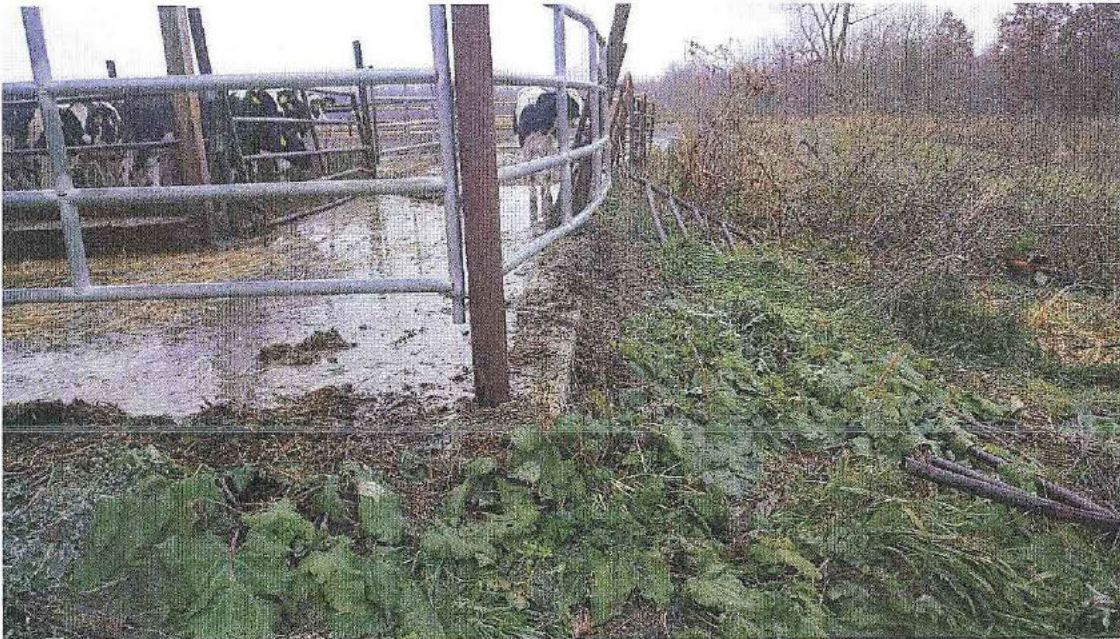
15: RIMG0015

Description: Looking south along west the Weaning Pen and associated outdoor lot.

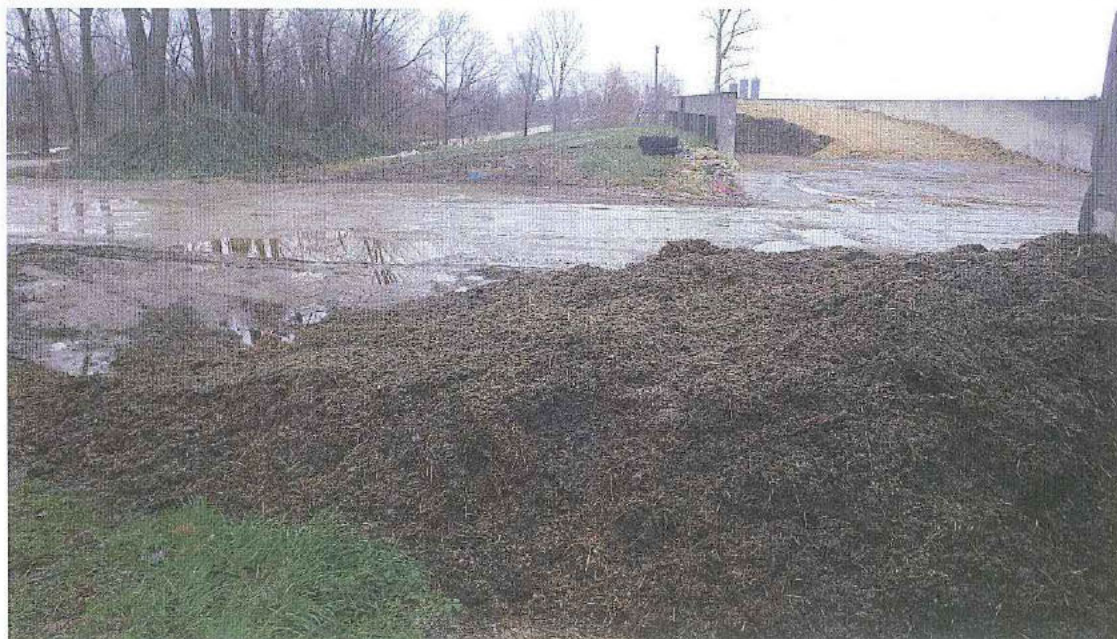
34: RIMG0034

Description: Waste silage and snow from road clearing activities on west side of west access road off of Stewart Road.

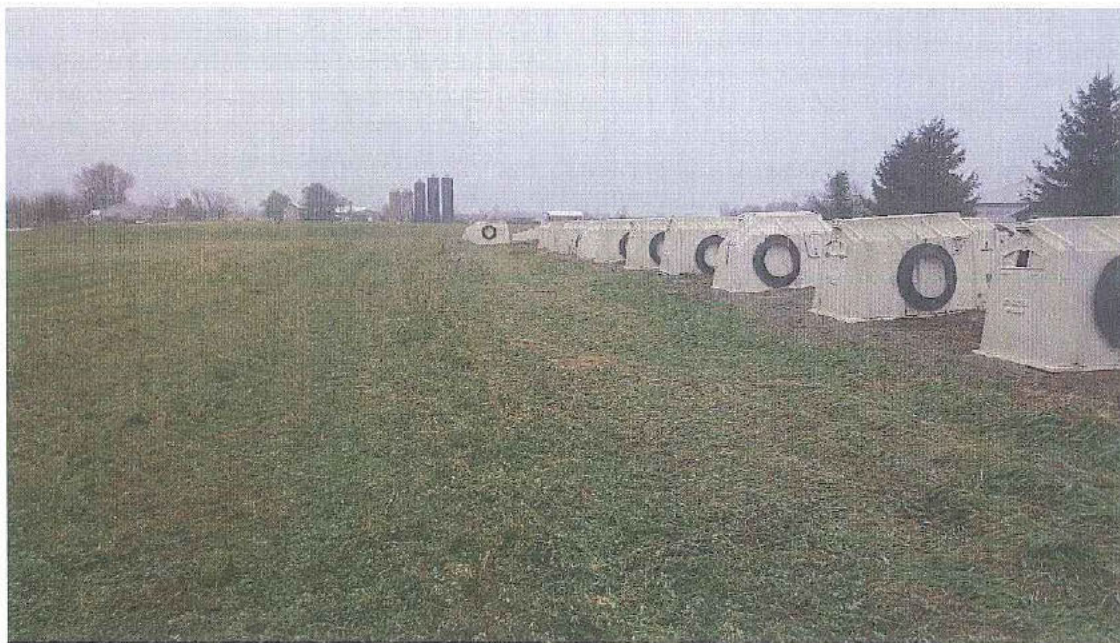
45: RIMG0045

9. EPA observed bedding and feed materials on the west side of the North and South Barns that could result in a runoff towards the wetland area to the west of the Facility. EPA also observed calf hutches with no secondary containment in an area that was sloped towards the inlet of a county stormwater drain.

Description: Looking east along northern edge of calf hutch area.

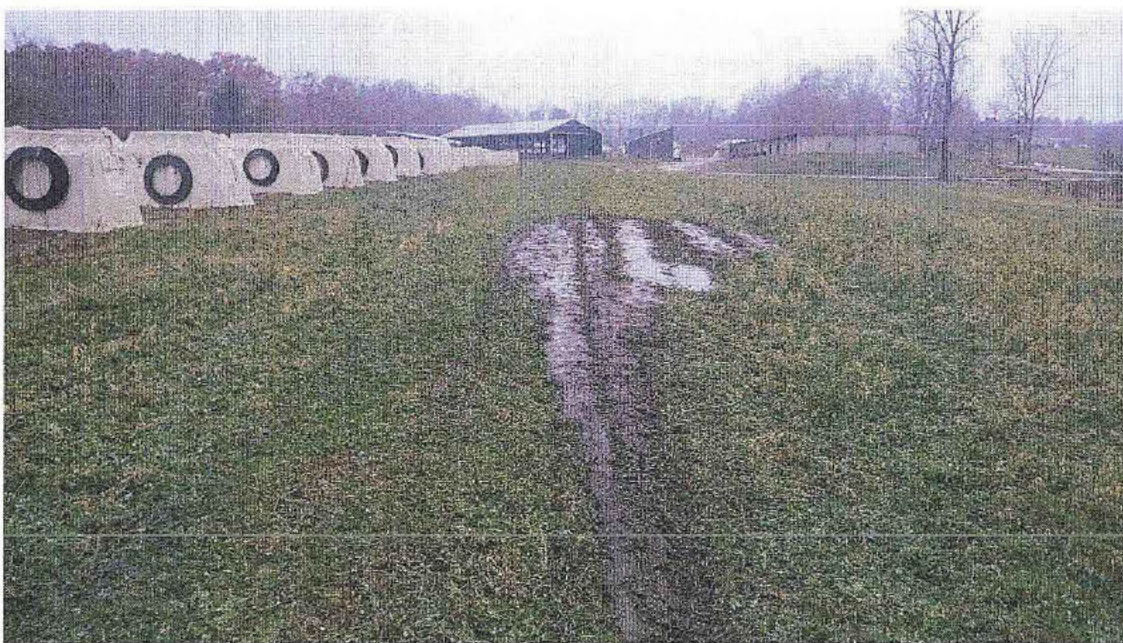
48: RIMG0048

Description: Manure from cleaning out of manure hoses in field north of calf hutch area.

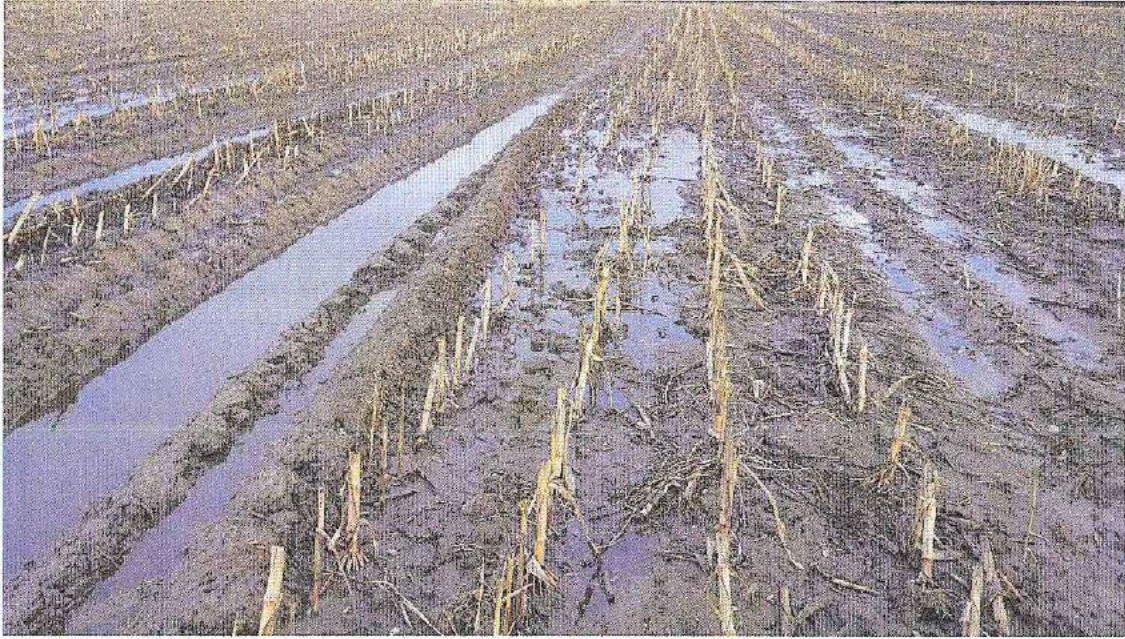
59: RIMG0059

EPA observed a truck hauling manure from the production area's Leachate Storage pond at approximately 10:30 am on November 21, 2019. Ex. 6 (Personal Privacy) (b) (6) stated that manure was being applied to Field Schauer East that morning. On November 22, 2019, at 10:20 am, manure on Field Schauer East was not yet incorporated.

Description: Land application at Field Ex. 6 (Personal Privacy) East approximately 18-24 hours after application.

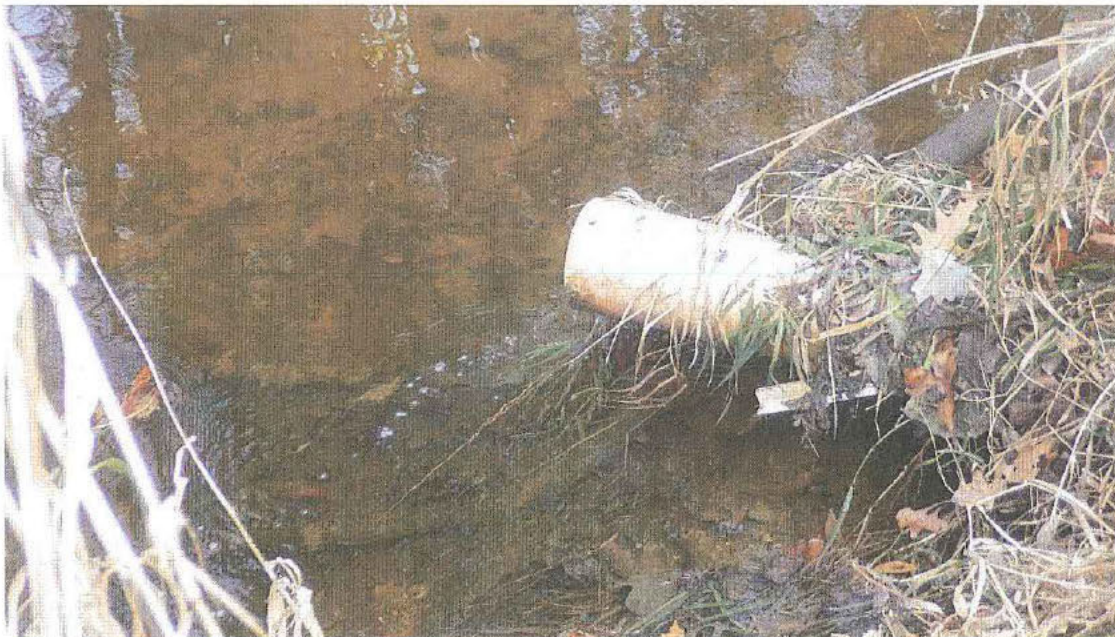
69: RIMG0069

Description: Field tile protruding from the eastern bank of the stream flowing along the west edge of the Field Schauer West.

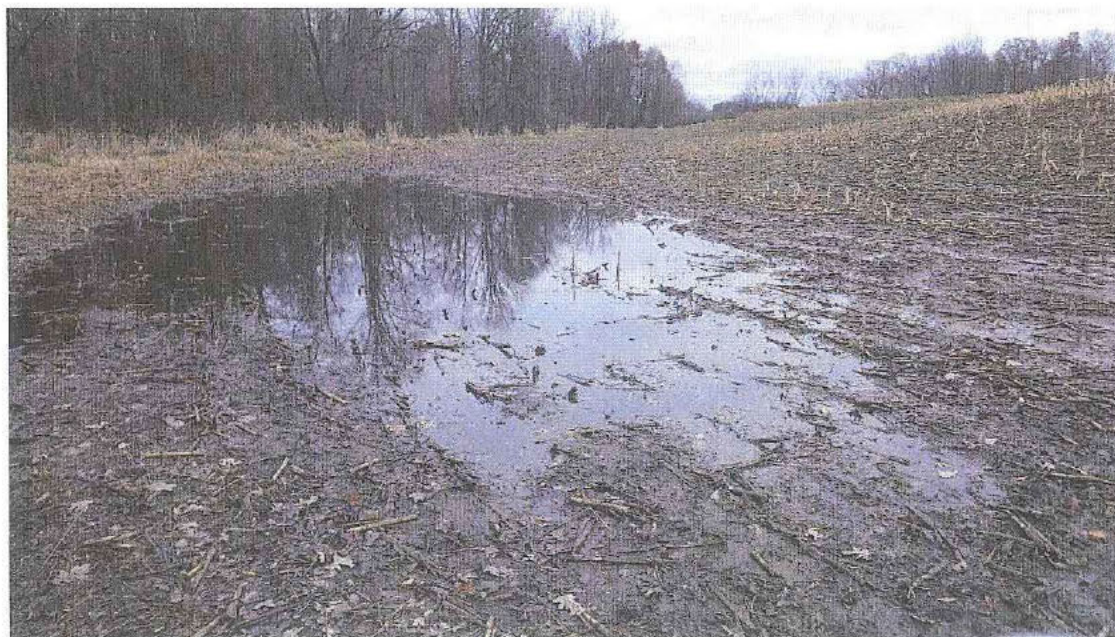
70: RIMG0070

Description: Water pooling at west side of Field [REDACTED] West near the stream. Manure was last applied on November 8, 2019.
